Report No. UT-10.20

ASSESSING CORROSION OF MSE WALL REINFORCEMENT

Utah Department of Transportation
Research Division

September 2010

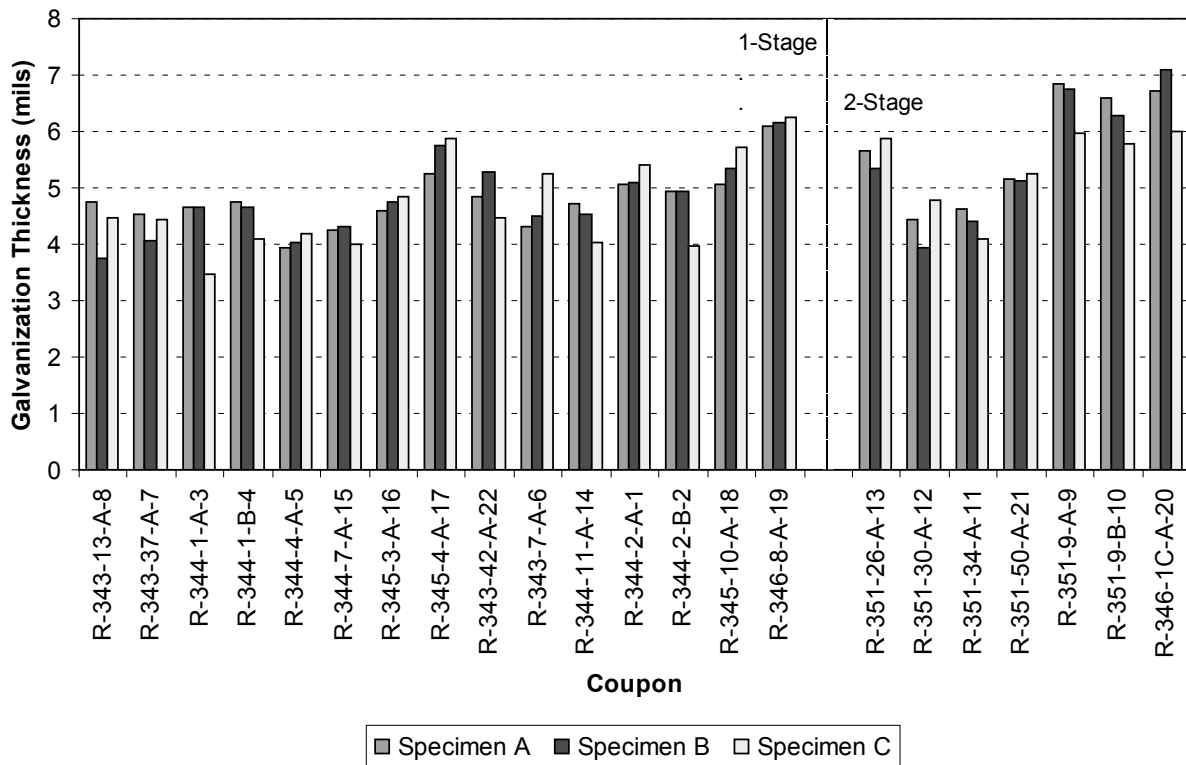
Figure 10 Variation in coupon galvanization thickness

The thickness of the coupon galvanization based on acid stripping as shown in Table 6 is presented graphically in Figure 10. In this figure, one-stage MSE walls are grouped on the left and placed in order of decreasing age from left to right, and two-stage MSE walls are grouped on the right and again placed in order of decreasing age from left to right. It should be noted that the maximum time differential between all of the walls is less than two years (although they all are approximately eleven to twelve years old), and construction dates more precise than the year built are not available.

It can be seen from the data that in all instances the amount of galvanization currently present on the specimens exceeds the amount specified at installation (3.4 mil or 2.0 oz/ft²). Based on AASHTO's design corrosion rate, 3.4 mil of galvanization should be consumed after sixteen years or about 0.5 mil remaining after eleven years. Even after acknowledging that the AASHTO design rates are conservative, it is still surprising that after eleven to twelve years so much galvanization is present (even exceeding the initially specified amount). Unfortunately, because the initial galvanization thickness is unknown, we are unable to estimate a reliable corrosion rate prior to the present time. However, the data describing current conditions can be used as baseline information going forward to compute corrosion rates in the future.

In an attempt to roughly approximate a corrosion rate, one might utilize the apparent trend in bar height from left to right (i.e., older to younger) in Figure 10 for the two different types of MSE walls. Unfortunately, since there is only one data point in 1999 for the two-stage MSE walls, any estimated rate for two-stage walls would be tenuous at best. A linear regression with respect to year built for the one-stage MSE walls indicates a corrosion rate of about 0.55 mil/year/surface. While this rate is similar to the AASHTO design rate for galvanization for the first two years after installation, the corrosion rate at this point in the walls' design life with galvanization still present is expected to be much less (consistent with the change in design corrosion rate for zinc after two years as shown previously in Table 1), leading us to doubt the accuracy of the calculated rate. Greater reliability could be realized if the time interval over which the regression was performed were greater than the nominal one-year time frame and more data points were available. It is also possible that the elevated rate partially reflects a seasonal or longer-duration variation in metal loss, the existence of which has been recognized by previous investigators (e.g., Fishman and Withiam (in press)).

Examining the data in Figure 10 to identify other corrosion trends, taken as a group, there seems to be little appreciable or consistent difference in galvanization thickness among the specimens located at different distances back from the face of the MSE wall. There may be a slightly elevated rate away from the wall face (which is the opposite of what we would initially suspect given the greater potential access to oxygen and moisture variations near the wall face). As indicated previously in Table 6, the average thickness of the 22 innermost specimens (specimens “C”) is 4.9 mil whereas the average thickness of the 22 outermost specimens near the wall face (specimens “A”) is 5.1 mil, a difference of about 0.2 mil. Since this difference represents about 3% of the overall average of the galvanization thickness for the 22 coupons (and recognizing that the trend is not discernable when considering median values rather than average values), any spatial differences seem to be materially negligible.

When examined with respect to wall type (recognizing that there is limited data with only 15 and 7 one- and two-stage MSE walls, respectively), the spatial pattern of decreasing thickness with increasing distance away from the one-stage walls is slightly more pronounced when considering median values (which may be more representative of “typical” conditions than average values because outlying data points can have greater effect when the sample number is small). In this case, the thickness of the innermost specimens is 4.5 mil whereas the thickness of the outermost specimens is 4.8 mil, a difference of about 0.3 mil (or about 2 years of galvanic corrosion based on AASHTO design rates). For the two-stage MSE walls, spatial trend is irregular, with the average and median values suggesting differing trends. Consequently, we are left to conclude that there is no readily discernable difference in corrosion rate as a function of distance away from the wall face.
